MAX-PLANCK-GESELLSCHAFT

DE602

Garching / Unterweilenbach

Maintenance in 2015 & 2016

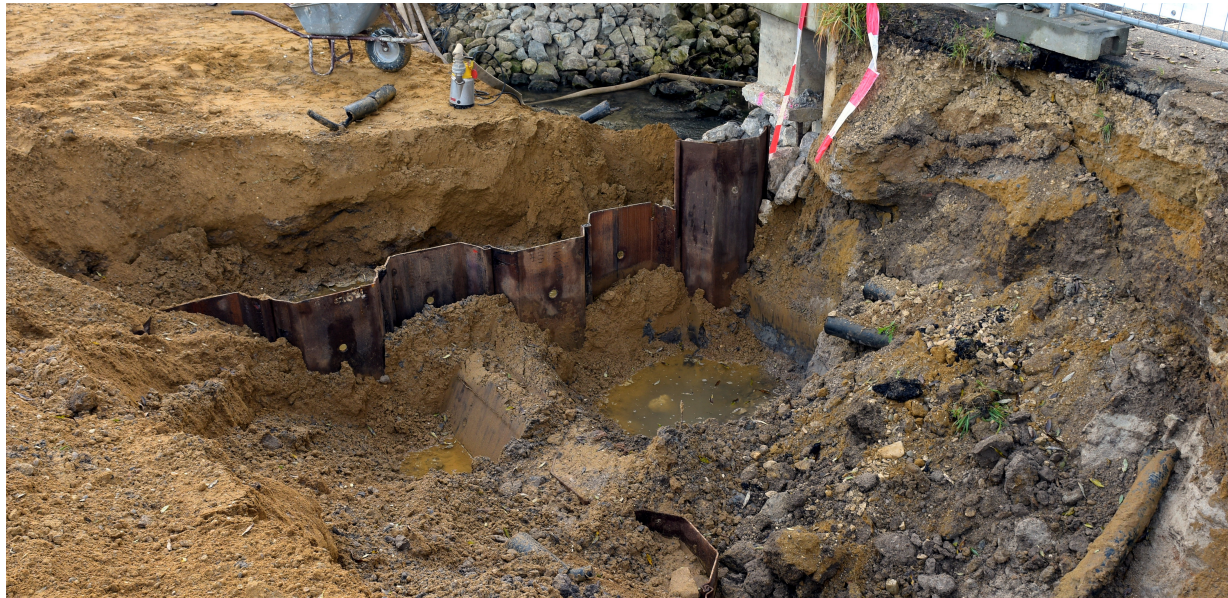
- While fibre connection was cut in Oct 2014 by pile driving ...

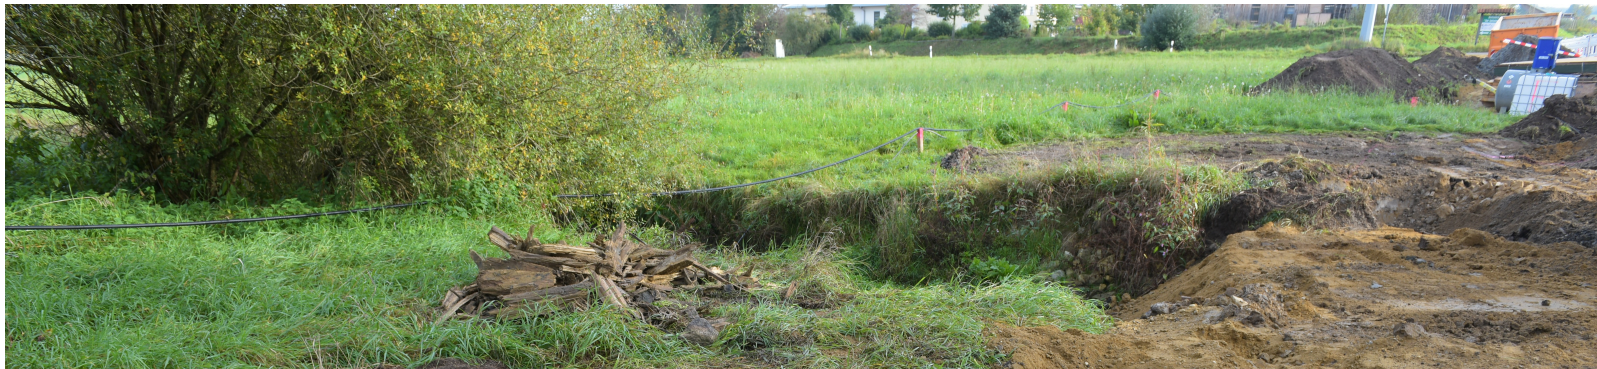
- ... other specialists decided to cut the cable again in Oct 2015 during mowing

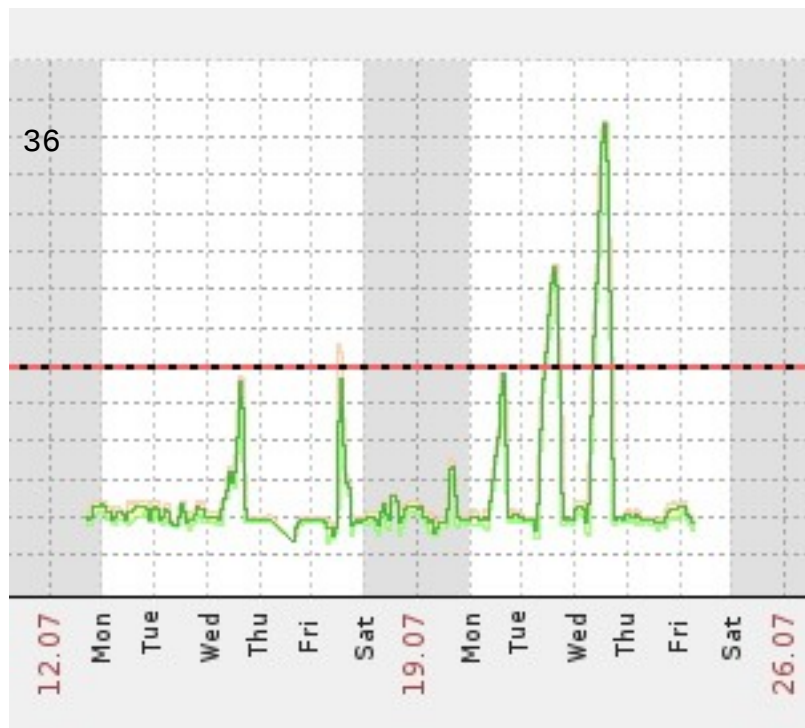
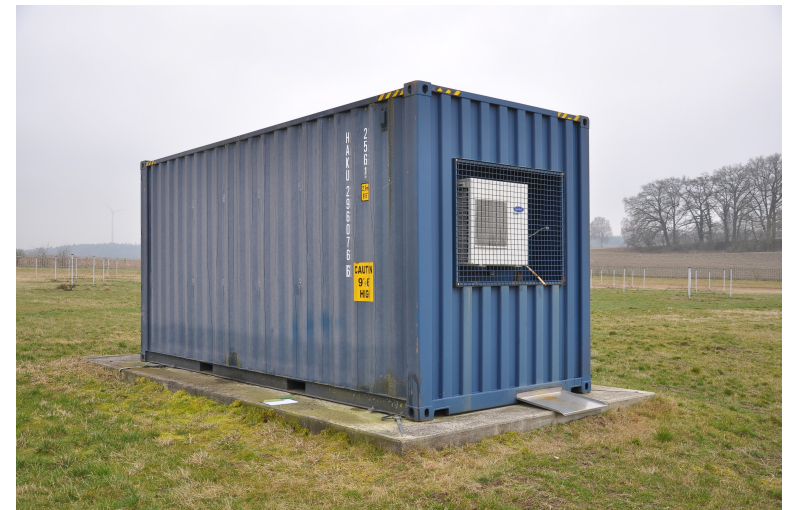
- extreme temperatures in summer 2015

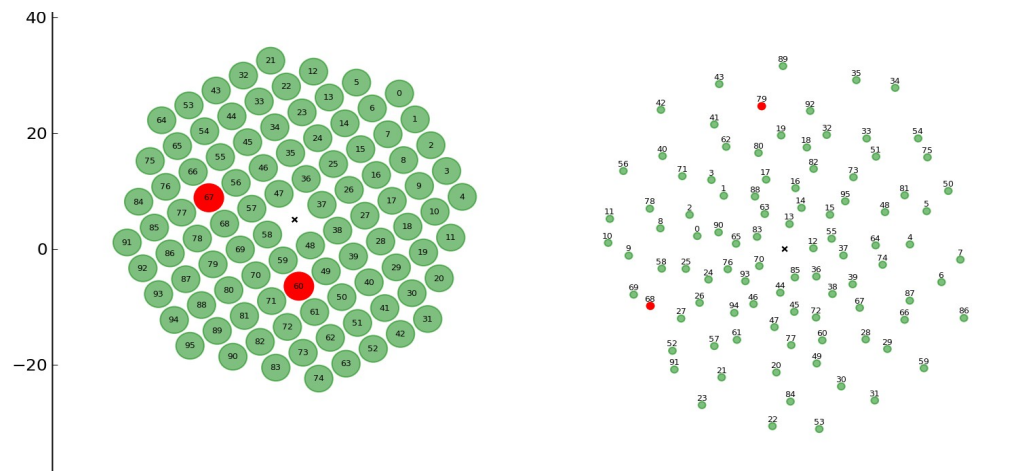
current situation (March 24)

- 2 LBAs & 2 HBAs marked as bad
- for the HBAs we are looking forward to maintenance visit
- for replacing LBAs I need replacement parts
