"CS1" Status 11 July 2007

Menno Norden

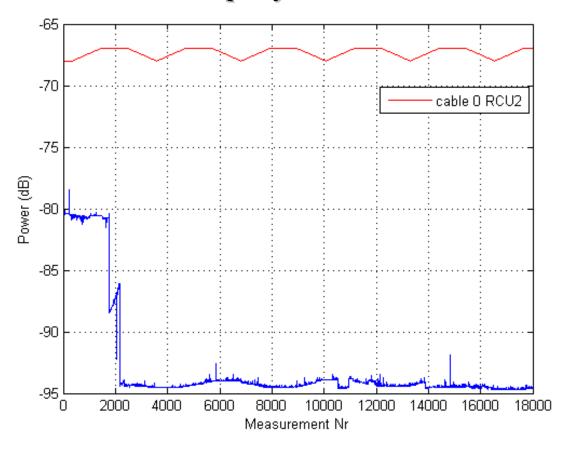
HBA Tiles on CS010 (Y polarity)

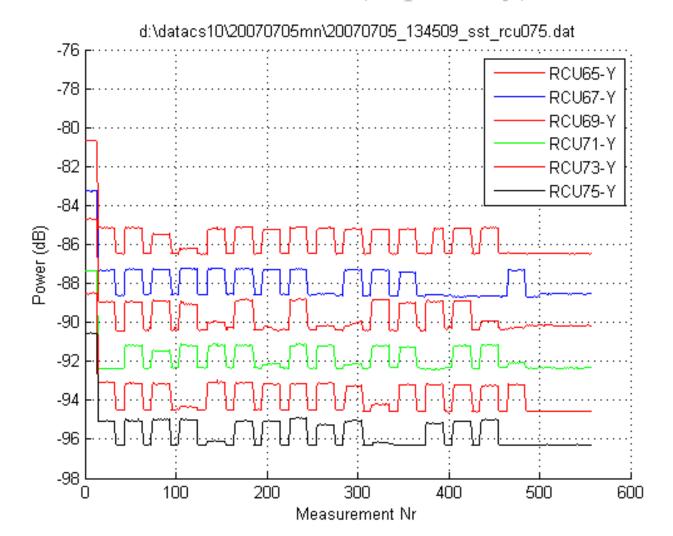
HBA inter tile check of failing FE units (05 July 2007)

| T1 - 64X 1,6,13 | (3) |
|---|---|
| total failing pol. | (41/192 = 21%) |
