"CS1" Status

29 Aug 2007

Menno Norden

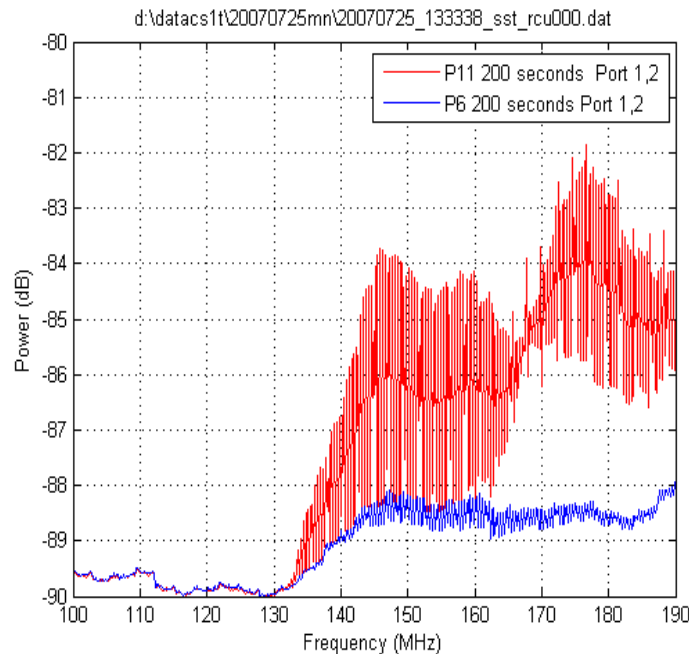
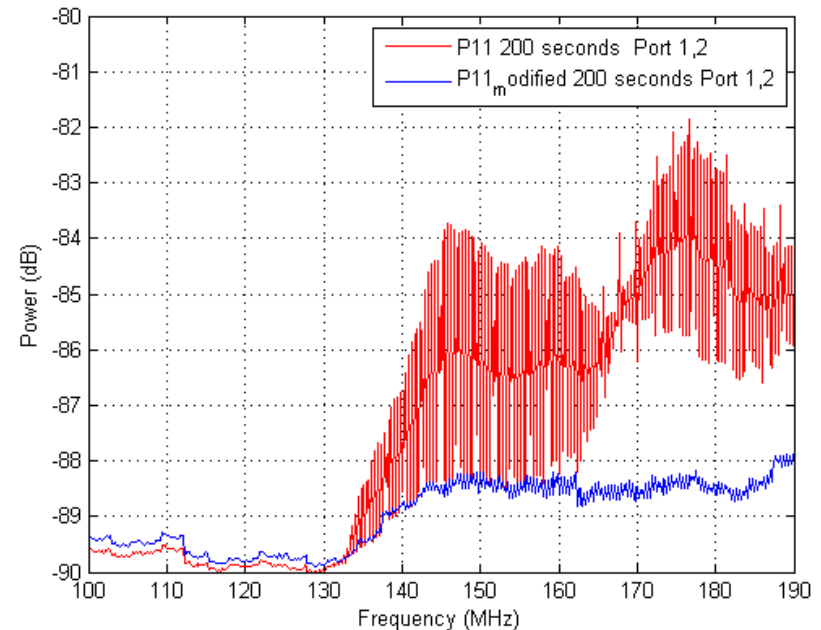
HBA sommator

- ◆ One tile sommator was very noise
 - ⊕ Sommator replaced in Tile
 - ⊕ Cause: One coil was not correct placed Port 2 (bypass)
