"CS1" Status 11 Oct 2007

HBA status

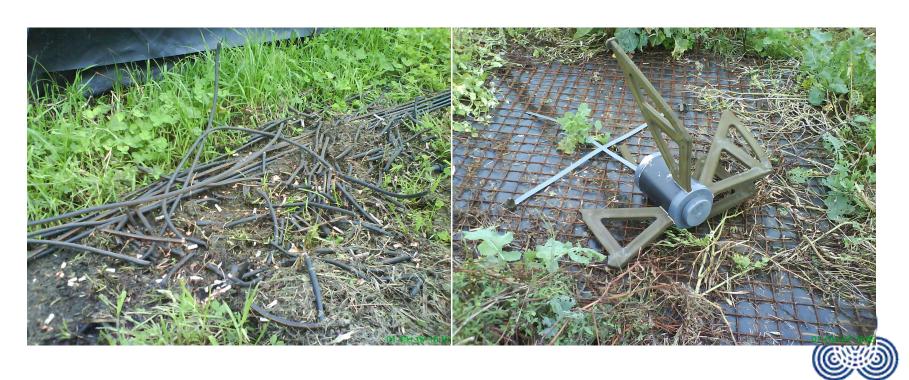
- ◆ 11 of the 12 coax cables where damaged
 - New cables are ordered and will be installed
 - One single element damaged (S29)
